DEPARTMENT OF DEFENCE
DEFENCE SCIENCE AND TECHNOLOGY ORGANISATION
AERONAUTICAL RESEARCH LABORATORIES
MELBOURNE, VICTORIA

Mechanical Engineering Technical Memorandum 409

**RESULTS OF T56 ENGINE PERFORMANCE MONITORING TRIAL
IN HERCULES AIRCRAFT, FEBRUARY-JULY 1977**

APRIL 1981

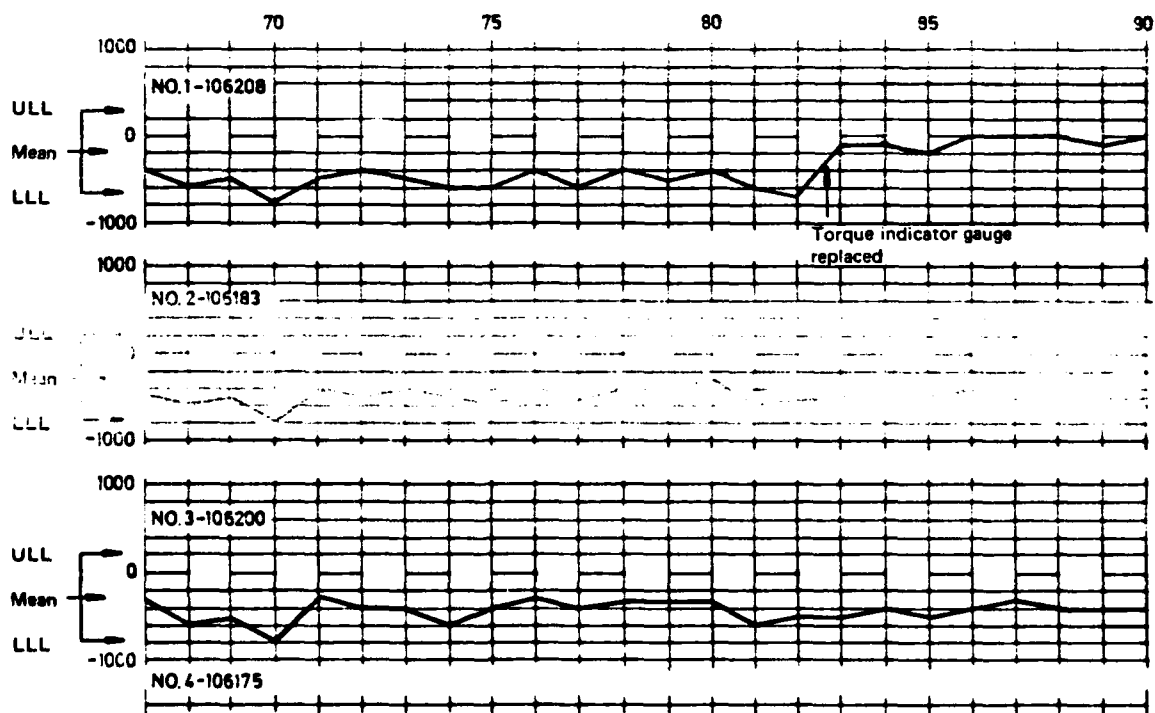
FIG. 5 TORQUE TRENDS

A general survey of the torque plot in Fig. 5 for engine 1 on aircraft 190 indicates that the torque level had been gradually falling, over a period of 6 weeks, until at about point 81 the lower limit line was encountered. At point 83, there is a sudden increase in torque and the 'normal' mean level is re-established. Reference to the EE 500's shows that the torque gauge was replaced between points 82 and 83: it is not known how long the flight engineer had been aware of the problem before reporting this malfunction.

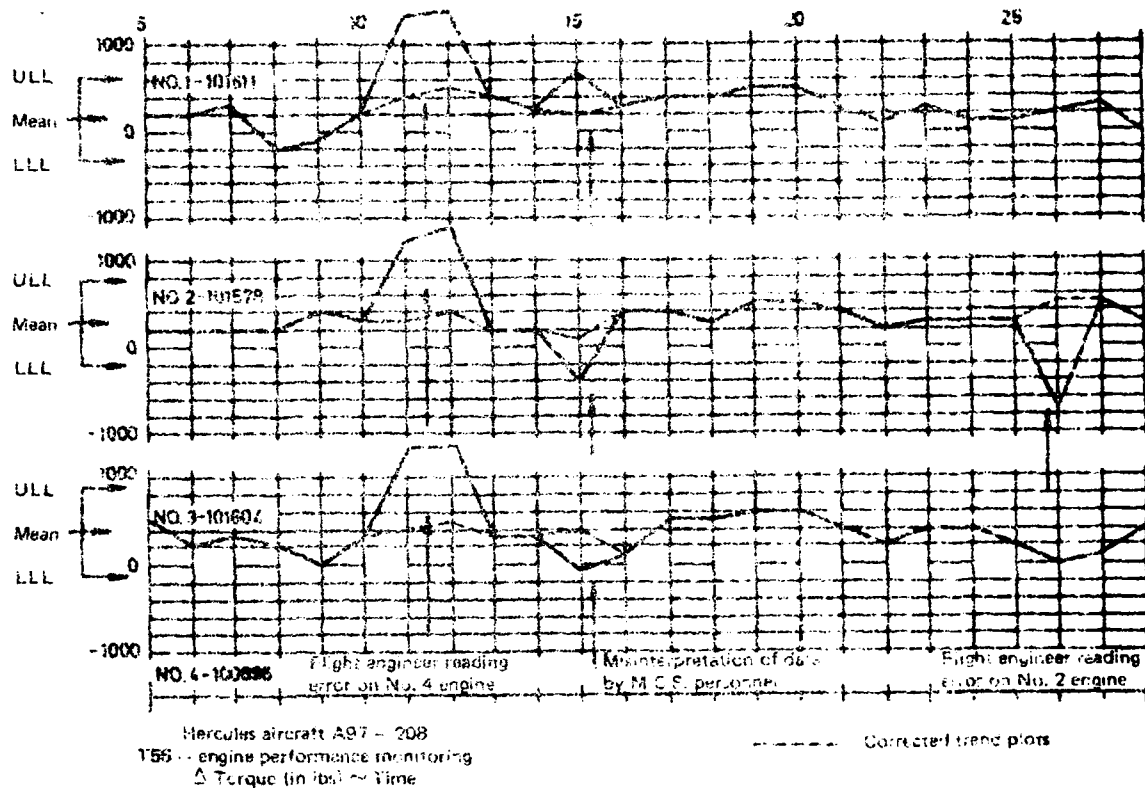
FIG. 7(a) TORQUE TRENDS

The torque and fuel flow trends given in Figs. 7a and 7b, for aircraft 208, show that there are at least four distinct changes in trend levels between points 5 and 45. On reference to the original data recorded by the flight engineer it was determined that the deviations at points 11-12 and at 26 in Fig. 7a were a direct result of a gauge reading error for the No. 4 and No. 2 engines respectively. The deviation at point 15 was attributed to a

misrepresentation of recorded data by personnel in the MCS. Corrected trend curves are indicated by the dashed lines in Fig. 7a. At this stage it must be stated that direct analysis and plotting of data in flight would obviate these problems. The other deviation observed between points 41 and 45 in Fig. 7b, was shown to be, on examination of the EE 500, a direct result of an unserviceable fuel gauge.
